HISTORIC STRUCTURE REPORT

COIT TOWER SAN FRANCISCO, CALIFORNIA

Dan Peterson, AIA, Historical Architect
Geraldine Peterson, Designer - Preservation Specialist
Ann-Marie Meenahan, Designer - Preservation Specialist
Interactive Resources, Inc.
Architects and Engineers
117 Park Place
Point Richmond, CA 94801
415-236-7435
Fax: 415-232-5325

April 1989

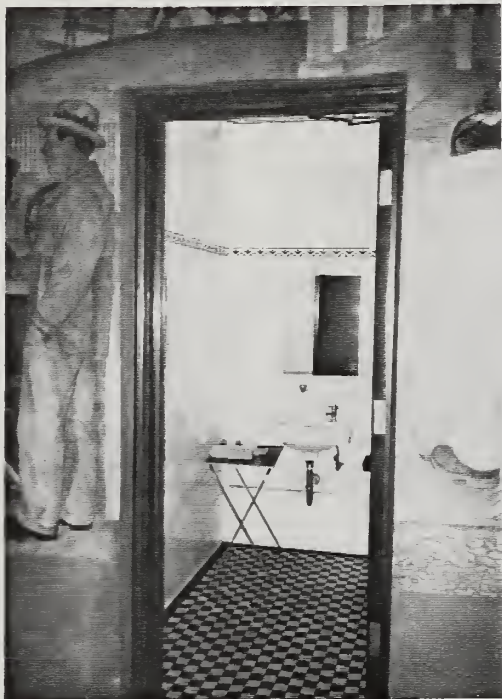
I-7. View into typical toilet room. (80-28A)

MATERIAL/TYPE	CONDITION	COMMENTS/RECOMMENDED TREATMENT
FLOOR	ceramic tile	good	Clean. Remove heavy wax build-up.
BASE	ceramic tile	good	Clean.
WALL	ceramic tile painted plaster	good good	Clean. Repaint to original color. Strip old paint to 4 mils or less if more than 15 mils thick.
CEILING	concrete	good	Clean and repaint to original color.
DOORS	solid wood	good	Strip old paint if more than 15 mils thick. Repaint with original color.
FIXTURES	metal ceiling hung incandescent	good	Repair when necessary.
OTHER	marble hanging stalls plumbing fixtures	good good	Clean with a non abrasive cleaner Periodically check for leakage.

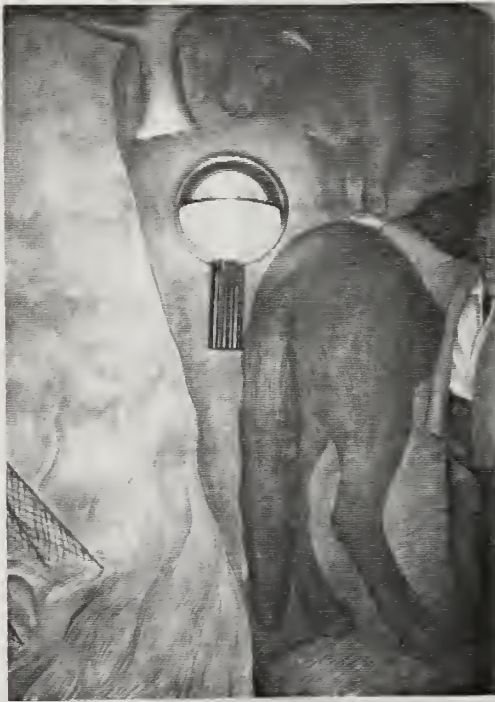
I-10. "Art Deco" light fixture.
South Gallery. (80-27A)

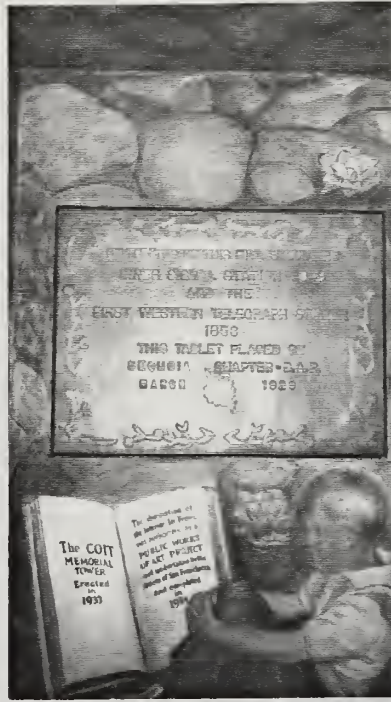
DAR PLAQUE	bronze	good	Commemorates the signalling station on Telegraph Hill (1849) and first western telegraph station (1853). Clean by conservator only.
PUBLIC PHONE BOOTH	plaster	fair	Repair and redesign more appropriately compatible to the historic integrity of the building.

I-11. *Dar* Plaque.
(80-26A)

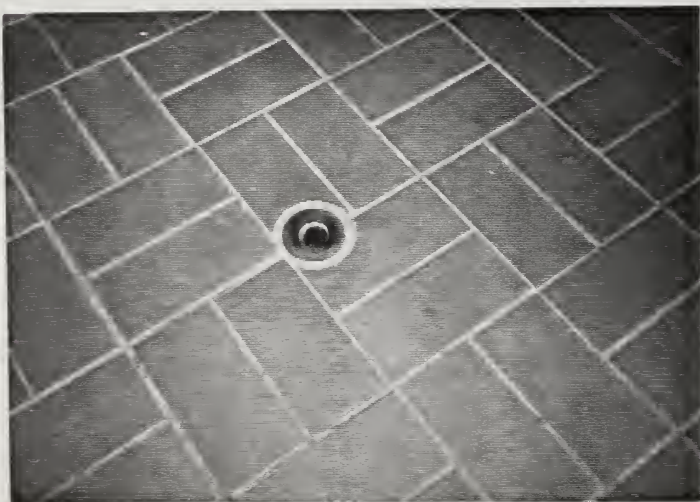
MATERIAL/TYPE	CONDITION	COMMENTS/RECOMMENDED TREATMENT
FLOOR	12" x 6" quarry tile	fair	Clean. Remove heavy wax build-up. Repair cracks and holes from barriers.
BASE	6" quarry tile	good	Clean.
WALL	frescos colored plaster	excellent good	Clean frescos by conservators only. Repair holes in walls from barriers with materials used by conservators when repairing frescos. Clean plaster with gentlest method possible.
CEILING	concrete	good	Remove paint to smooth surface. Repaint original wheat color with terra cotta color border at frescoes.
DOORS	solid wood	good	Strip finish if over 15 mils. Repaint when needed original aqua green color and texture. Clean hardware.
FIXTURES	metal ceiling hung incandescent	good	Good example of "Art Deco" Style. Wiring for hanging fixtures should be checked and fixtures cleaned to remove corrosion by a professional in historic light fixtures, such as Nowell's Victorian Lighting (415/332-4933).

I-13. Hole in quarry tile from barriers.
(81-32A)

There will be an installation of barriers for the murals on the first floor in the near future. Construction of the barriers should be monitored to prevent damage to the murals and heavy damage to the quarry tile floor.

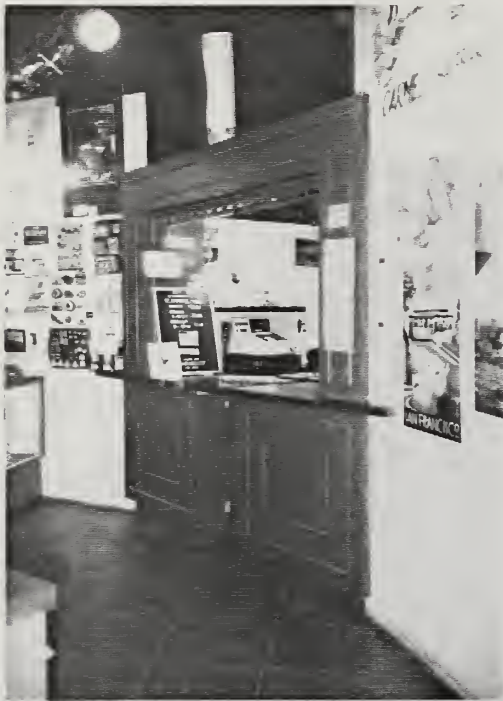
I-15. View of built-in cabinet. (82-34A)

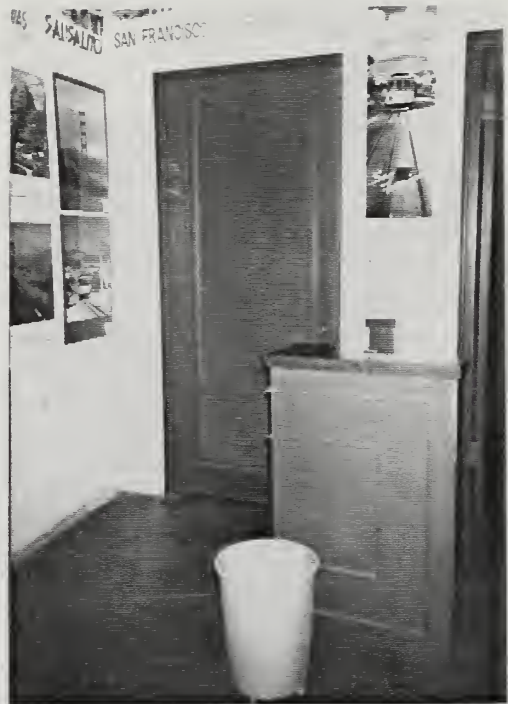
I-16. Louvered door and counter. (82-35A)

MATERIAL/TYPE	CONDITION	COMMENTS/RECOMMENDED TREATMENT
FLOOR	concrete	good	Clean. Eventually replace with quarry tile.
BASE	no base		
WALL	concrete	fair	Clean. Paint.
CEILING	concrete	good	Clean. Paint.
DOORS	solid wood louvered	good	Strip finish if over 15 mils. Repaint when needed original aqua green color and finish. Clean
hardware.			
FIXTURES	metal ceiling hung incandescent track lighting	good	Repair when necessary. Replace with more compatible when possible.
FURNITURE	formica, wood cabinets	good	Non compatible. Entire space should be redesigned to be more compatible to the historic integrity of the building.

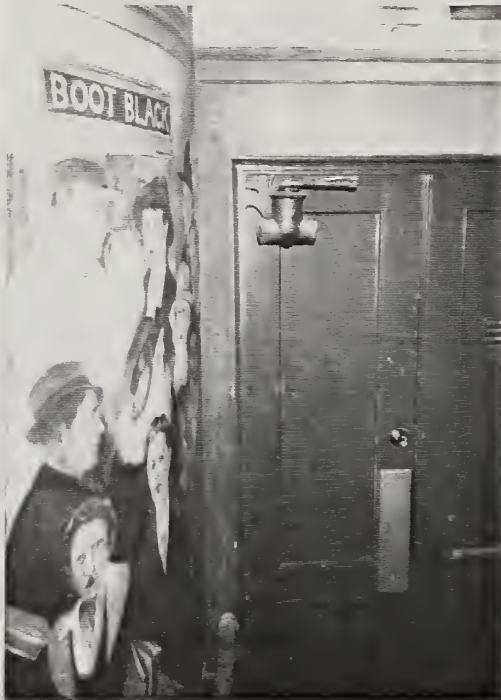
I-17. Fresco murals and wood door.
(57-04A)

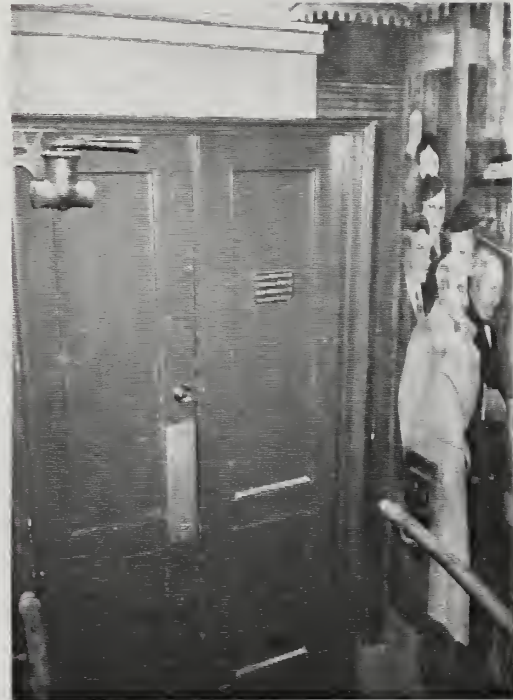
I-18. Fresco murals. (57-06)

MATERIAL/TYPE	CONDITION	COMMENTS/RECOMMENDED TREATMENT
FLOOR	concrete	good	Clean.
WALL	frescos colored plaster	fair fair	Clean and restore by conservators only. Clean plaster with gentlest method possible.
CEILING	plaster/concrete	fair	Repair cracks and water damage. Paint of ceiling and trim appears to be original.
DOORS	solid wood	good	Strip finish if over 15 mils. Repaint with correct paint color. Clean hardware.
RAILINGS	galvanized metal	good	Railings have chips of different colors of paint in places indicating that they were painted several times. Pineapple endings, a symbol often used to represent hospitality. Detailing and sharp edges on endings worn down. According to Arthur Brown Jr.'s specifications, the interior iron stair railings were not intended to be painted. Remove all remnants of paint.
FIXTURES	wall mounted	good	Repair when necessary.

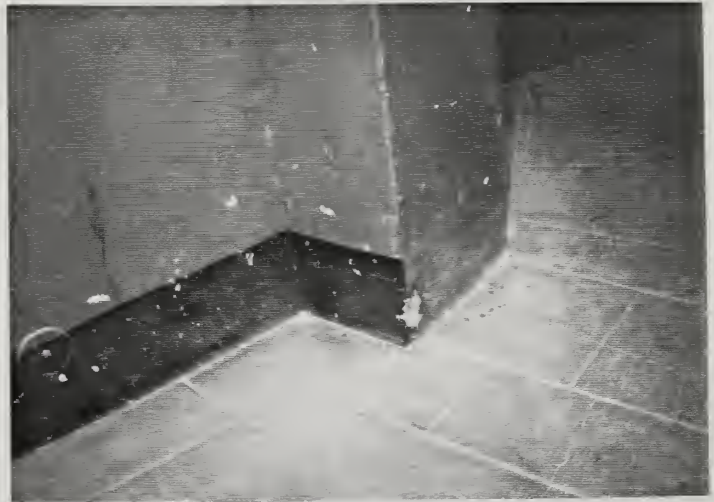
I-24. Chipped plaster on wall.
(65-08A)

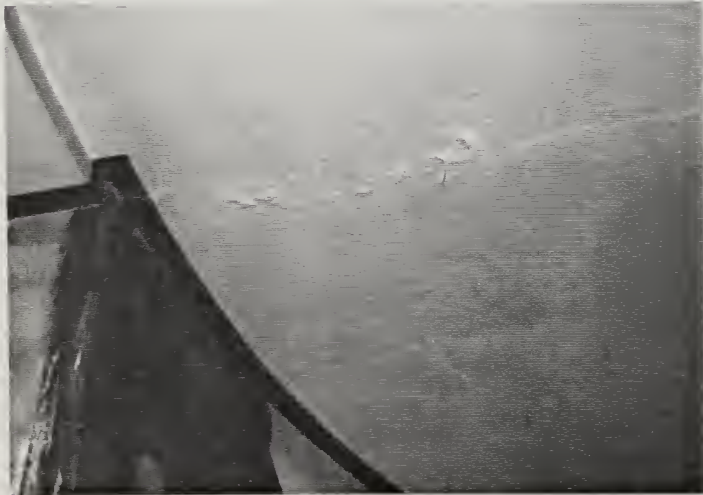
I-25. Typical damage on ceiling.
Painted trim. (58-10)

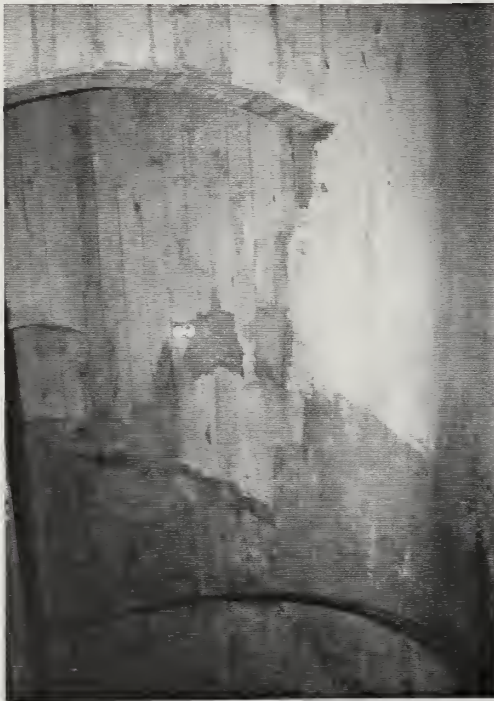
I-27. Concrete patches throughout tower stair.
Typical wall hung light fixture. (20-09A)

MATERIAL/TYPE	CONDITION	COMMENTS/RECOMMENDED TREATMENT
FLOOR	concrete	good	
WALL	concrete	fair	Existing patching does not match. Repatch with more compatible composition, color, and texture.
CEILING	concrete	fair	
DOORS	solid wood	good	Repaint when necessary with correct paint color; clean hardware.
RAILINGS	galvanized metal	good	Pineapple endings, a symbol often used to represent hospitality. Detailing and sharp edges on endings worn down. According to Arthur Brown Jr.'s specifications, the interior iron stair railings were not intended to be painted. Remove all remnants of paint.
FIXTURES	wall mounted ceiling hung	good good	Exposed light bulb. Repair when necessary. Light bulb hanging from a chain. Repair when necessary.
WATER TANKS	metal plate	fair rusting	Material indicated on shop drawings as "plate." Tanks should be drained and alternate water supply developed. Danger of leak into structure above murals.

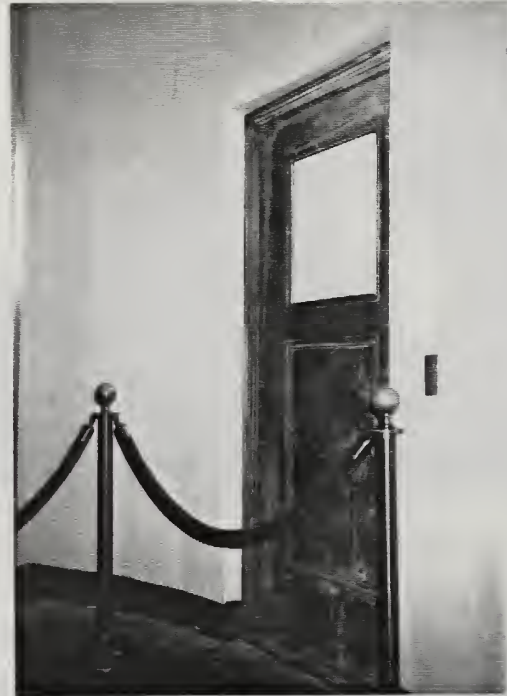
I-30. Exterior door and barriers.
(72-34A)

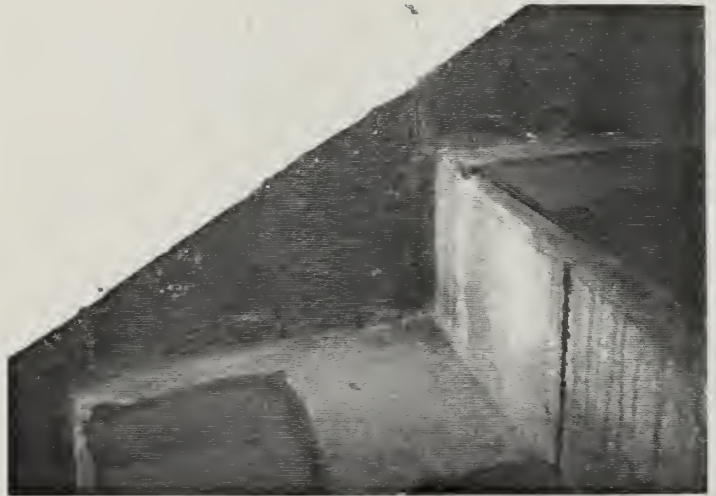
MATERIAL/TYPE	CONDITION	COMMENTS/RECOMMENDED TREATMENT
FLOOR AND STAIRS	concrete	good	Clean. Repair treads.
BASE	painted concrete	fair	Repaint with original colors.
WALL	painted concrete	fair	Repaint with original colors.
CEILING	painted concrete	fair	Strip old paint if more than 15 mils thick. Repaint with original color. Clean hardware.
DOORS	solid wood elevator door metal door	good good good	Strip paint if more than 15 mils thick. Repaint with original color. Clean and refinish.
RAILINGS	galvanized metal	good	Railings have chips of different colors of paint in places indicating that they were once painted several times. Pineapple endings, a symbol often used to represent hospitality. Detailing and sharp edges on endings worn down. According to Arthur Brown Jr.'s specifications, the interior iron stair railings were not intended to be painted. Remove all remnants of paint.
FIXTURES	wall mounted ceiling hung	good good	Repair when necessary.

I-32. Detail of painted concrete
wall. (68-17A)

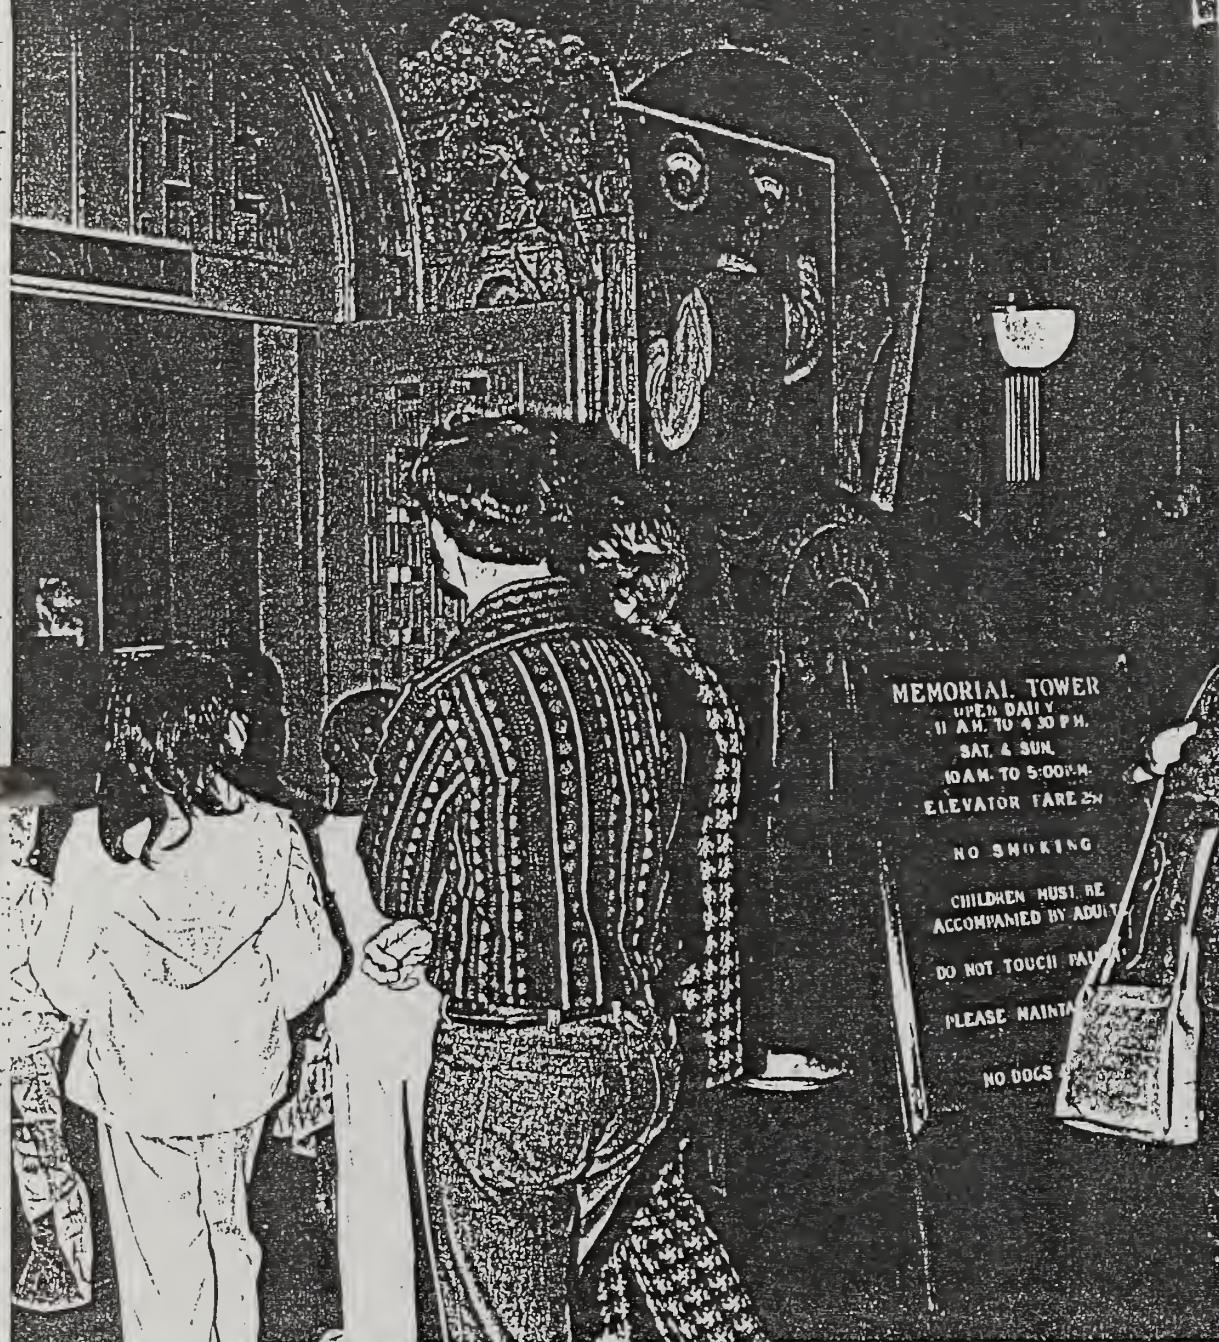
ENTRANCE LOBBY

Hundreds of people go through this dark hall every day on their way to the elevator lobby. Two more ceiling lights would show the frescos to better advantage. Protective poles with leather-covered chain between would help to prevent scratches on the walls. (frescos by John Langley Howard, Ray Boynton)

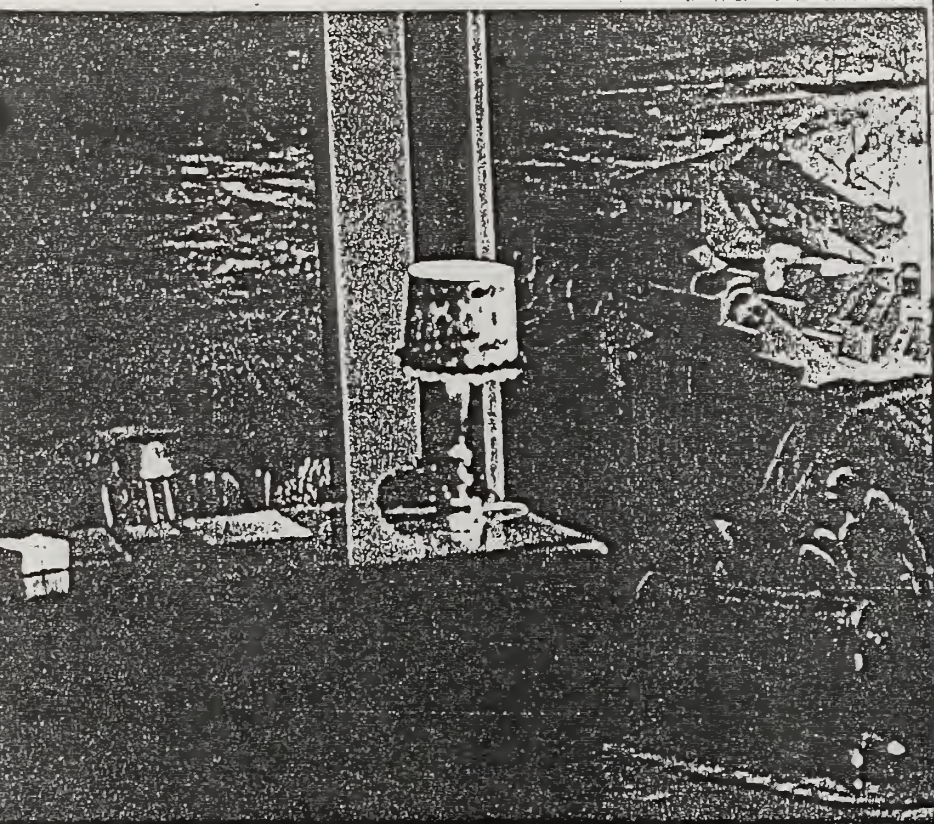
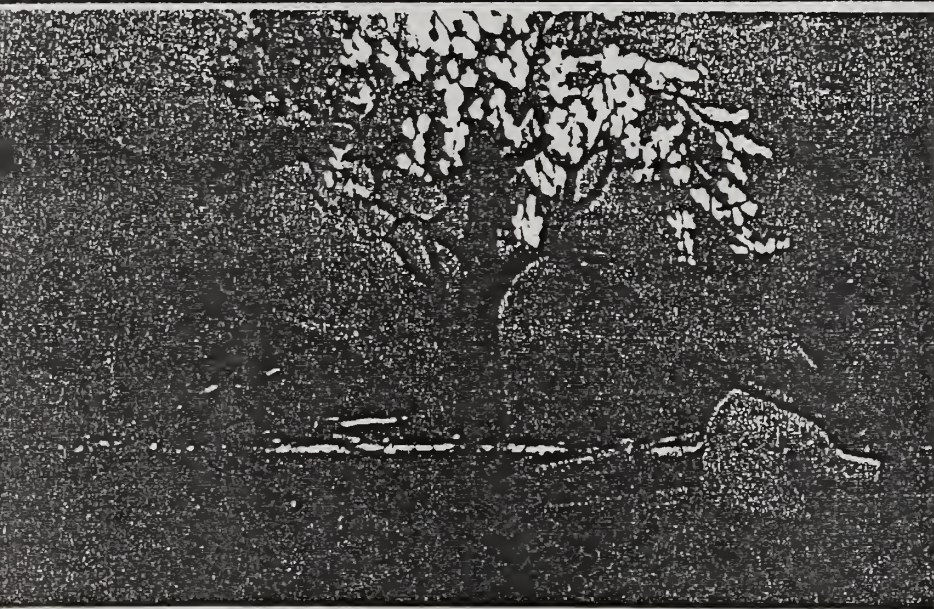
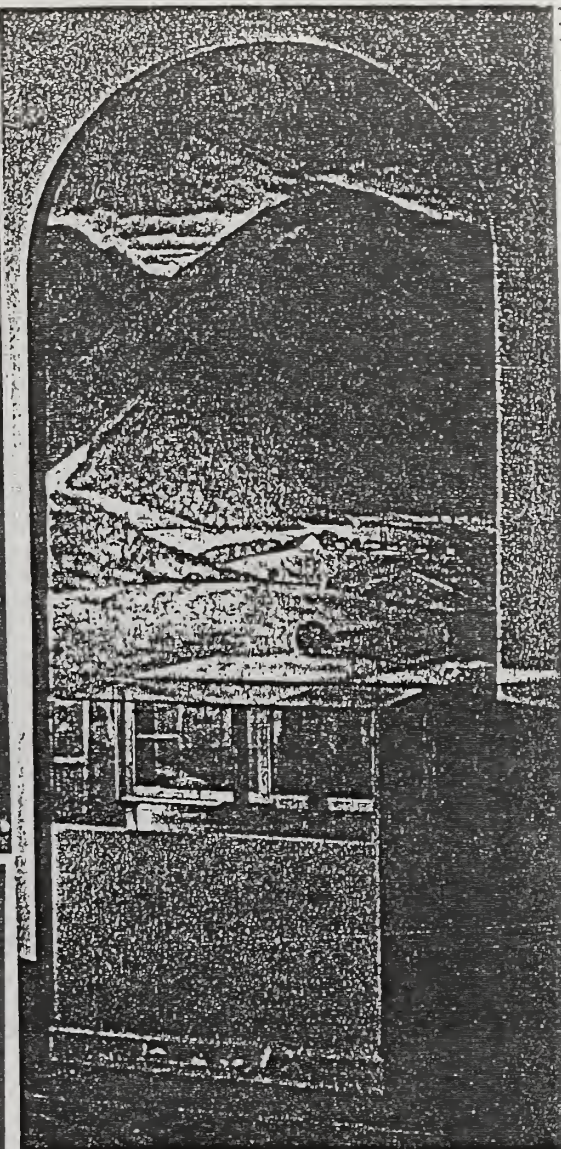
ELEVATOR LOBBY

The photographs on this page show the elevator lobby as it is today. It is much too dark to see the beautiful oil landscapes by Rinaldo Cuneo. They are also half concealed by the desk and a display case. The oil by Moya del Pino, to the right of the desk, is being damaged by a 200-volt electric heater placed near it.

Beamer-Wilkenson, an excellent lighting firm who do museum work, have made several suggestions on ways to improve the lighting. One is simply to remove the etched glass tubes from the center fixture, releasing more light from the two 200-watt bulbs. Another possibility would be shaped lights installed around the ceiling fixture and focused on the paintings.

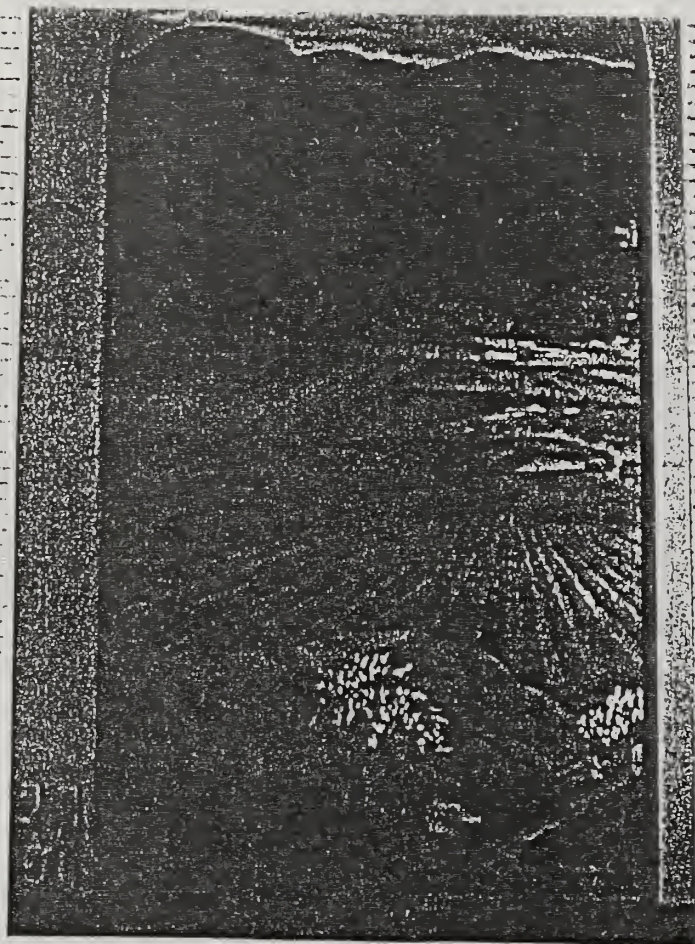
landscape by Rinaldo Cuneo

Rinaldo Cuneo's beautiful landscape is behind the desk, and so poorly lighted that it is almost invisible. Lighted, it becomes a richly-colored painting which adds to the beauty of this very simple, pleasant small room. To its left are the two green doors which could be used for the ticket-selling operation. (See drawing by Groth)

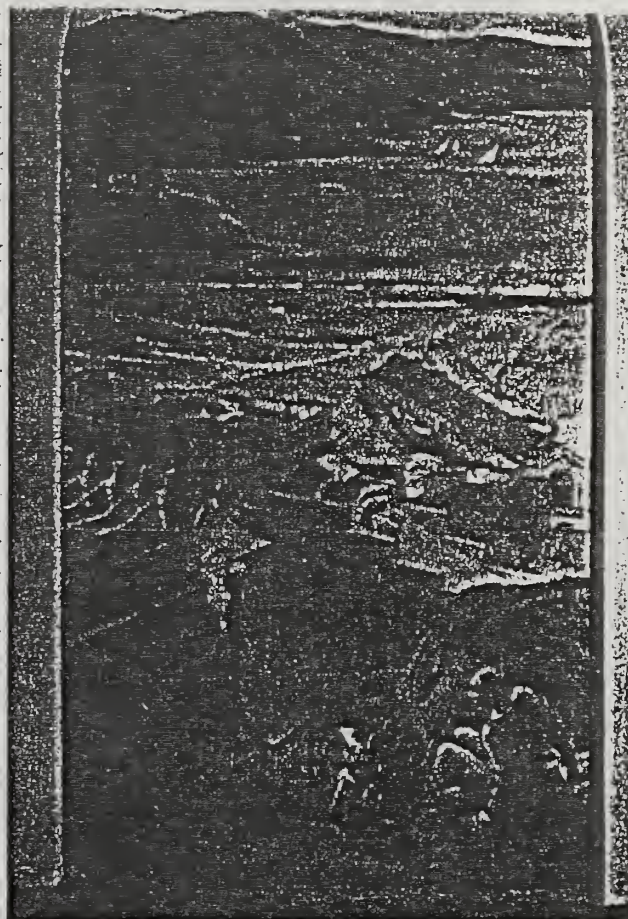
Moya del Pino's painting to the right of the desk. Note the brown square in the sky (detail below in black and white). This was the film of dirt we removed, which covered all of these paintings.

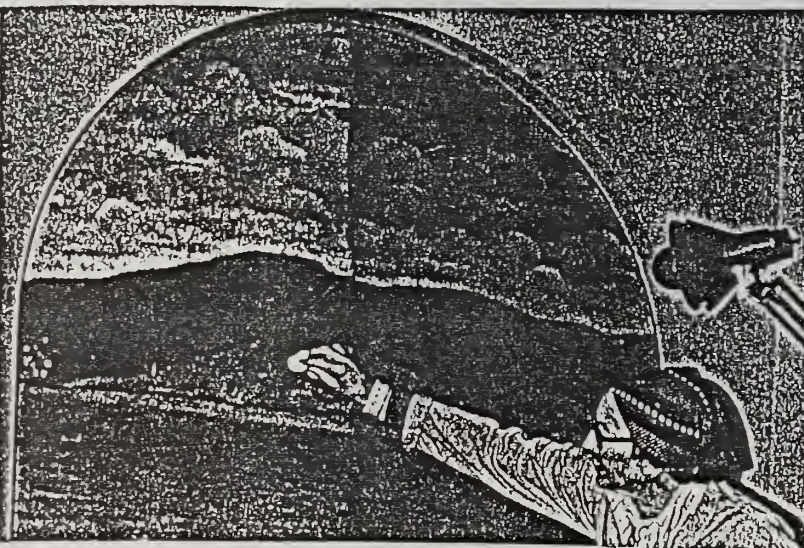
Emmy Lou Packard working on
half-cleaned painting.

The four oils and the two lunettes in the elevator lobby were cleaned carefully according to instruction by the foremost experts in the field of restoration. Then, on the same advice, the paintings were varnished with acrylic.

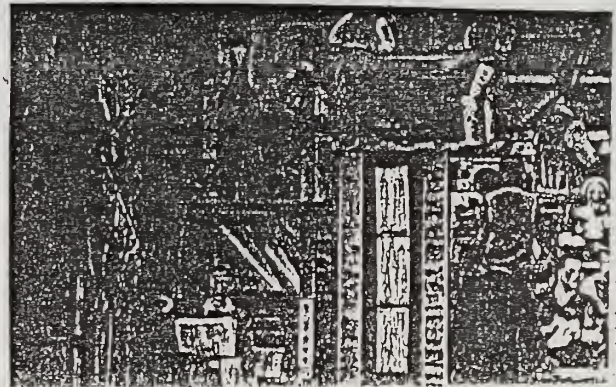
Rain damage under narrow window in fresco by John Langley Howard

Beside the two large areas of rain damage shown on the previous page, Rosinda Holmes and I repaired extensive damage around the eight narrow windows: six to ten chips in the plaster from window replacement on every one of the narrow windows; rain damage similar to the example shown above, under every window; on the fresco walls in the outer hall, ground floor galleries, stairs and upstairs walls we repaired and retouched 565 small scratches, chips, holes in the fresco plaster.

TO SAVE COST OF CONSTANT REPLACEMENT AND DAMAGE TO PLASTER, these narrow windows should be glazed with bullet-proof plastic glass (available under several brand names). To cut down the blinding light which prevents one seeing the corner frescos clearly, a 1/8" pane of gray plexiglass might be placed over the inside of the small panes.

All of the frescos were retouched with thin acrylic*(Liquitex and distilled water). Under the windows we added two coats of matte medium to protect this area from rain damage, after retouching.

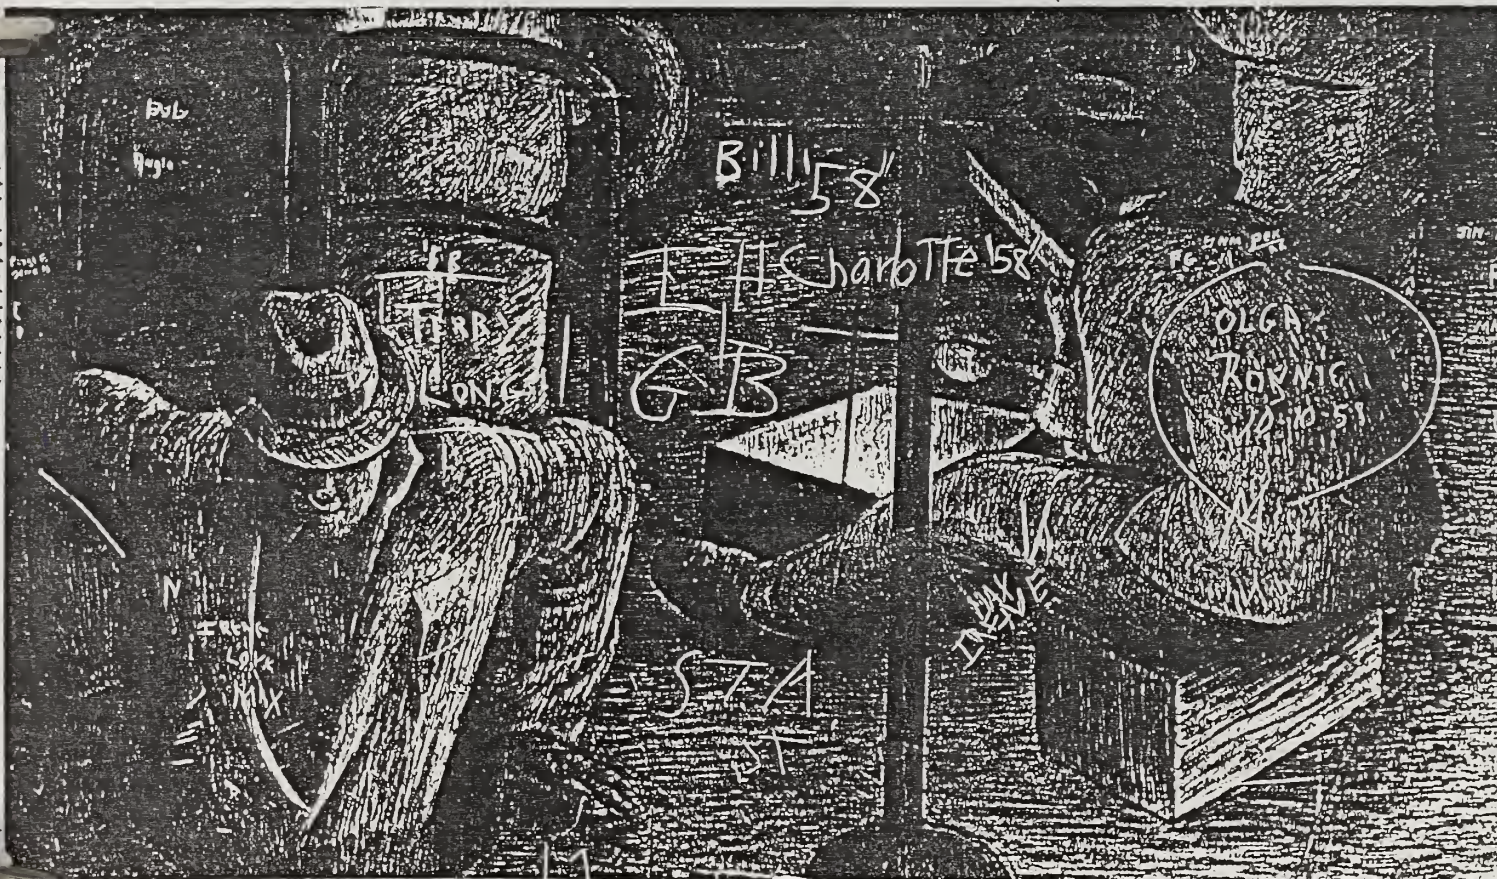
Photographs of damage repaired by Dorothy Cravath in 19 60-62 (under supervision of restorer Henry Rusk)

Arnautoff fresco, 1960 (fragment of photo by Ruth Teiser & Catherine Harroun)

Extensive damage had to be repaired at the top of the stairway in 1960-62 (on the mural by Lucien Labaudt). Plastering was done by John Wong (according to Dorothy Cravath's daughter). All of these repairs were supervised by Henry Rusk.

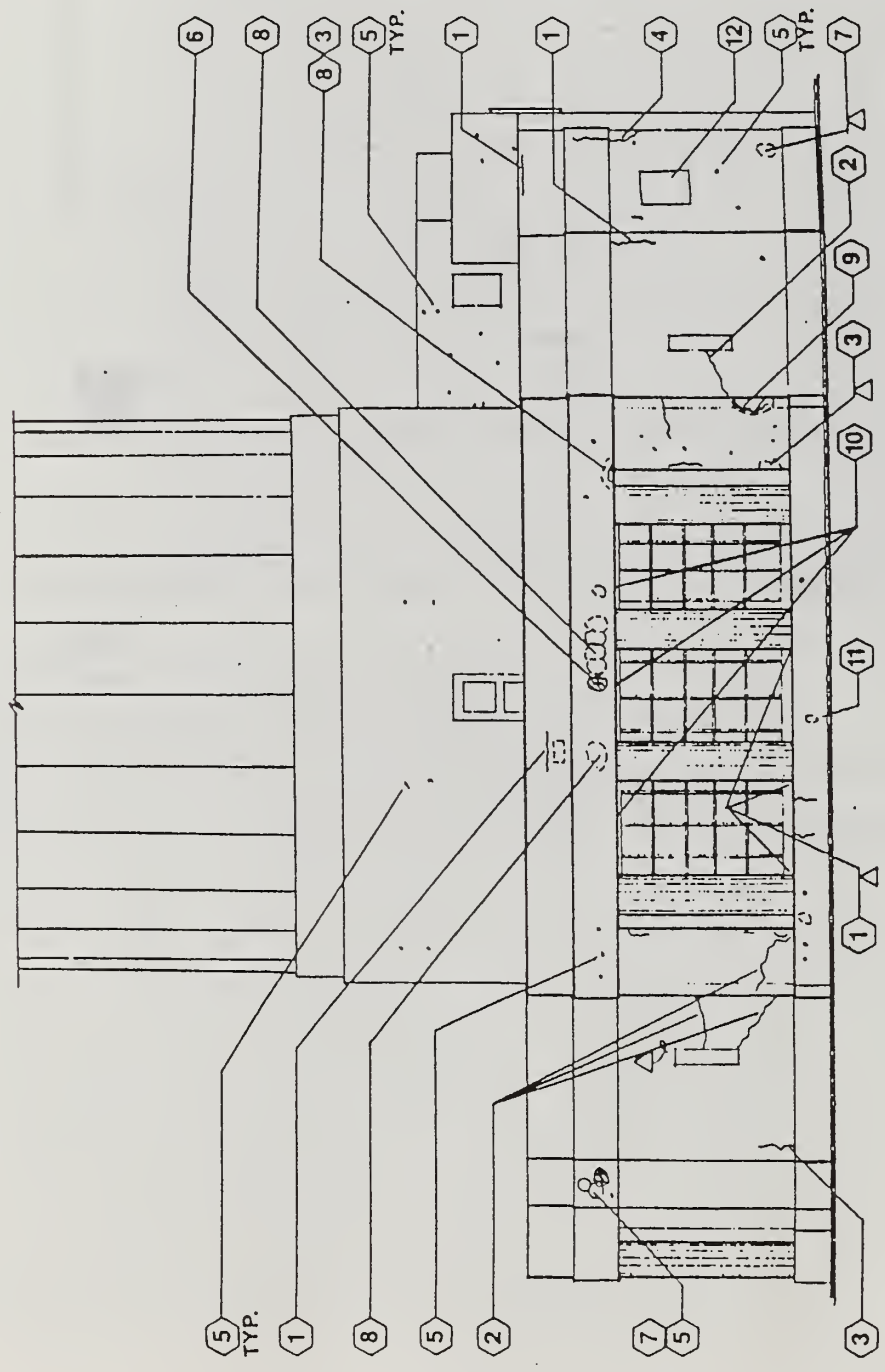
Figure 3

12	Cracking and water leakage at wall grate.	1 Ea.	E-h
13	Cracking and spalling around pipe.	N/A	G-d
14	Large spall area above first floor entry.	N/A	G-f
15	Horizontal patched crack in parapet	N/A	E-j
16	Vertical patched crack in second floor wall	N/A	E-j

2 EAST ELEVATION - BASE

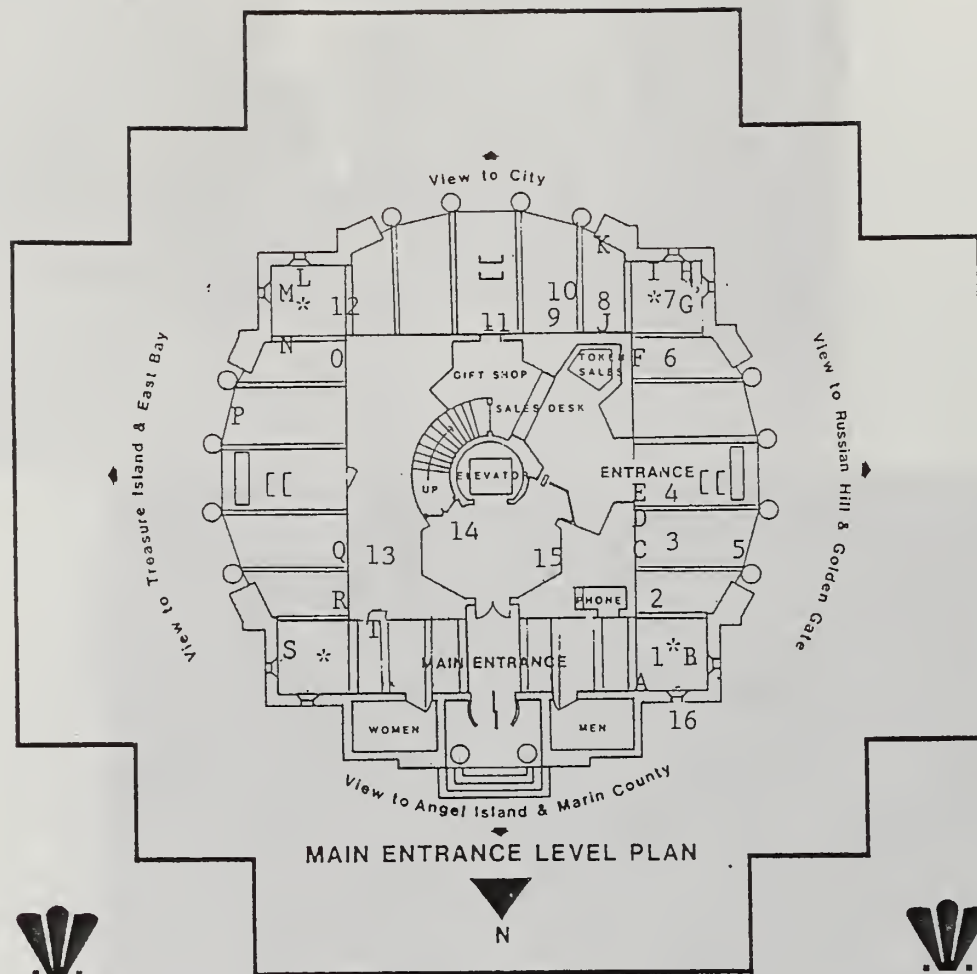
4. Coit Tower. Ground Floor Plan (Friends of Recreation and Parks).
Legend:

While all of these features could conceivably contribute to the problem of infiltration of water, it is evident that infiltration has been chronic and localized for many decades. Figure 4 and Photographs 6-27 show the locations of infiltration of water, and deterioration of architectural surfaces in proximity to the frescoes. It is interesting to note that the water problems are concentrated on the west (weather) side, and that the deterioration of the frescoes occurs almost exclusively in proximity to failures in the structure. However, heaters and cameras inserted through the roof may also act as conduits for infiltration.

- 1-15 Infiltration of Water
- A-T Water-related Damage to the Frescoes
- [[Heaters Installed through the Roof and Ceiling
- * Cameras Installed through the Roof and Ceiling

A program of roof repair has been proposed. Its objectives will be implementation of seals at all junctures, and creation of an impermeable layer over the original concrete slab. It seems likely that these interventions will arrest most of the infiltration. However, the possible contribution of pipes, conduits and recent installations of heaters and cameras to the

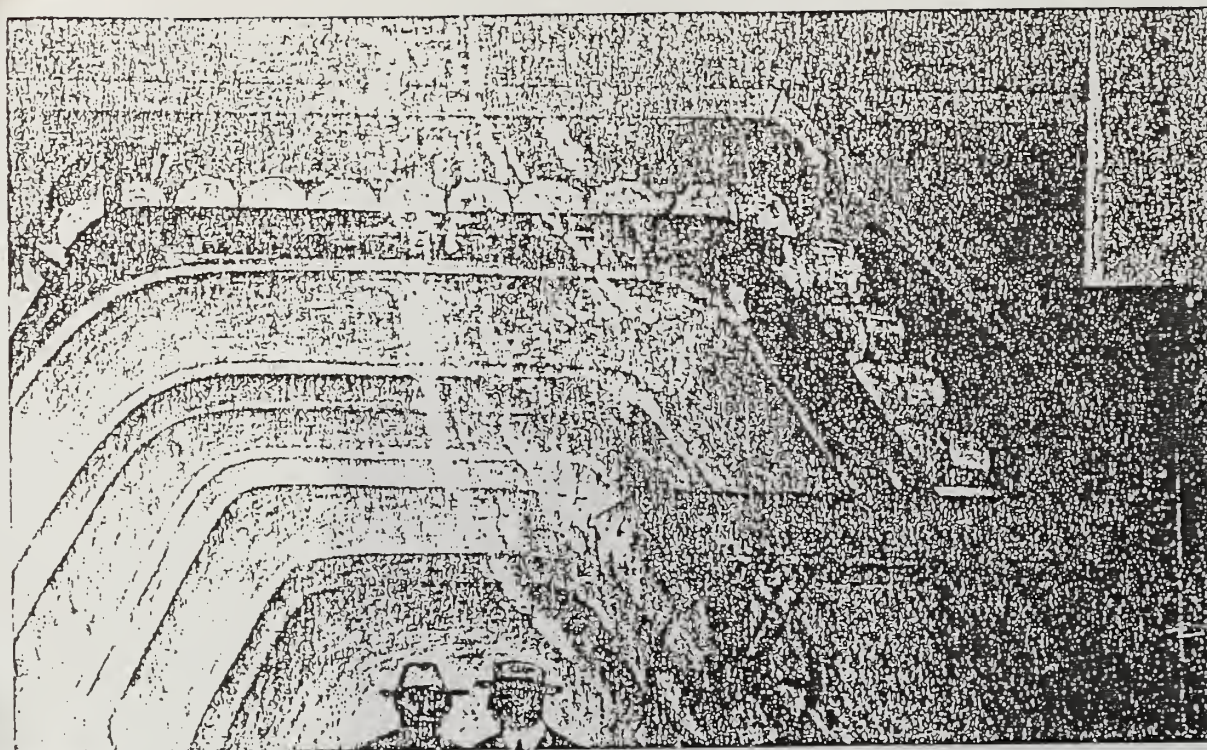
31. Area before 1975 treatment

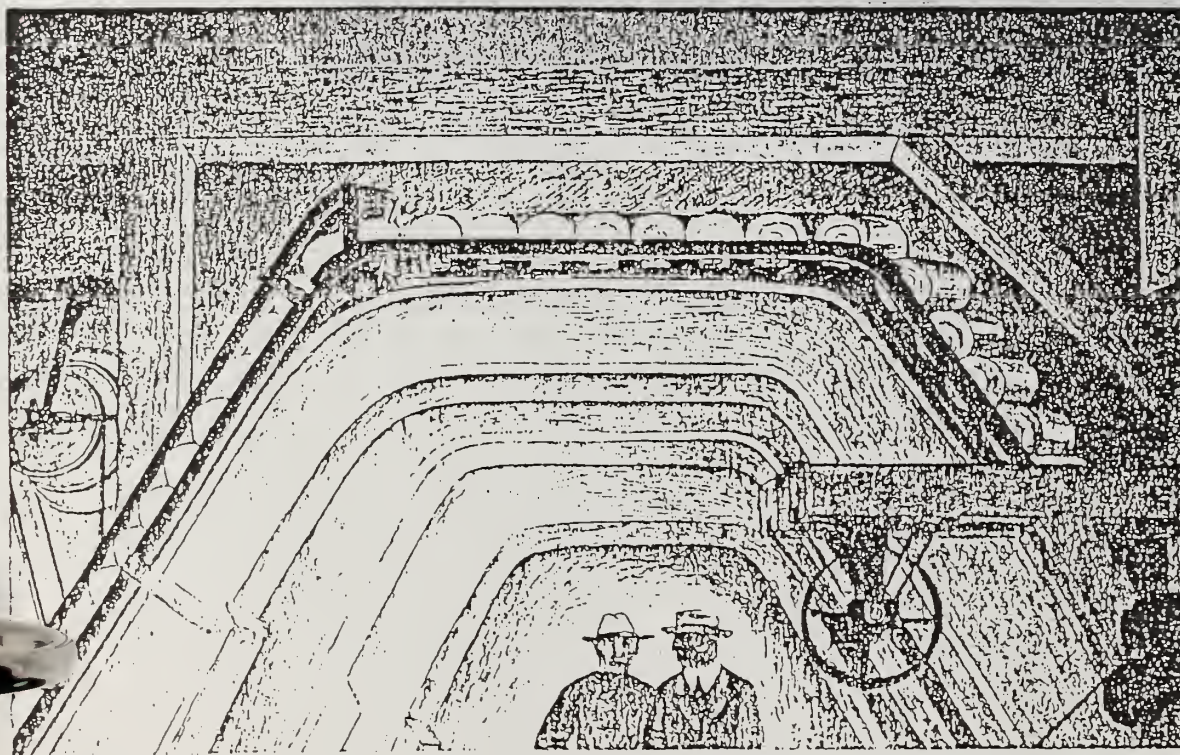
32. Area after 1975 treatment
